Product Alert

Type of Notification: Counterfeit Valves

Description: Angle Hose Valves
Make/Model: A155, 1.5" and 2.5"
Nameplate data: "GIACOMINI ITALY"
FM Approval status: FM Approved

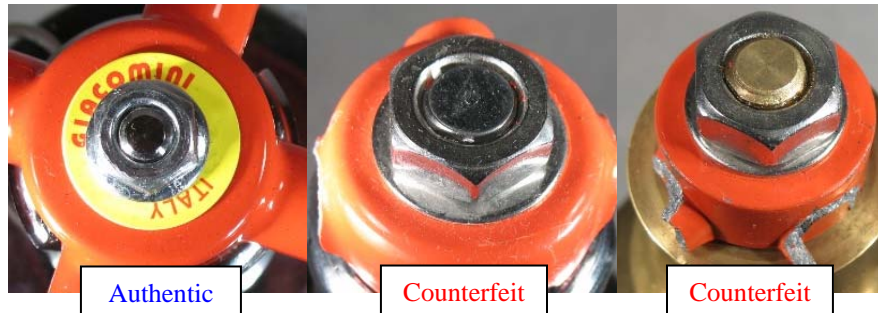
Figure 1

To the left in the above figure is the stem nut and name plate of the authentic Giacomini A155 valve. A flanged nut is used for the stem nut and the name plate reads "GIACOMINI ITALY." To the middle and right are counterfeit valves. The stem nuts are not flanged and a separate washer is used under the nut. A name plate is not used in the counterfeit versions. Giacomini uses a 1/2" size stem nut, while a 17 mm and a 19 mm nut were found on the counterfeit valves.

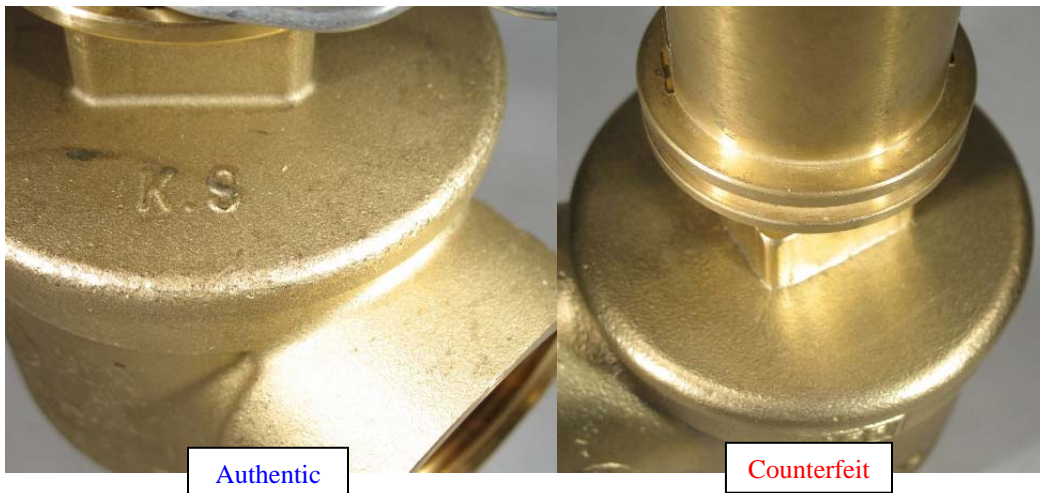
Figure 2

The above photographs show the date code applied to the bonnet of the authentic A155 (right). Neither counterfeit valve had a date code on the bonnet or anywhere else on the valve body.

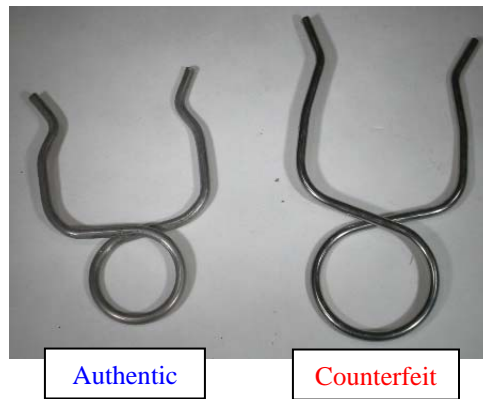
Figure 3 above shows the authentic stem cover brake next to the brake found on the counterfeit valve. The authentic brake is smaller but made from thicker gauge wire. The difference in design is not inconsequential as seen below in Figure 4.

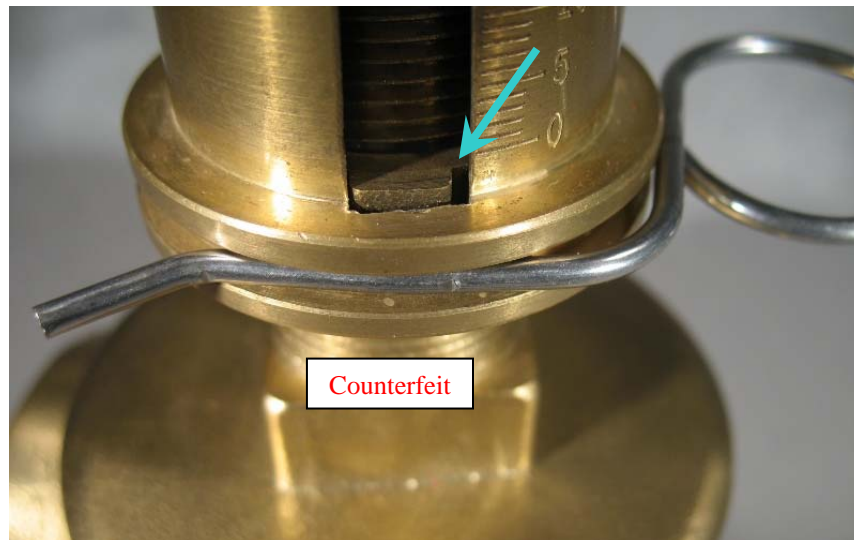
Figure 4 above shows the counterfeit brake inserted into the channel of the counterfeit valve stem cap. The valve stem cap is affixed to the stem, while the stop block indicated by the blue arrow is affixed to an extension of the bonnet and hence remains stationary as the valve is opened and the valve stem moves upward. There are two slots cut into clip channel on the stem cap which allow the brake to impact the bottom of the stop block as the valve is opened and the stem, stem cap and clip move upward, thus providing a stop and producing a throttling effect. As shown in Figure 4, because of the poor design of the brake, when the brake is inserted fully it does not impact the stop block allowing the valve to be opened past its set point. If this valve were to be used in its capacity as a pressure reducing device, this flaw could allow for excessive water pressure to be delivered to the hose line.

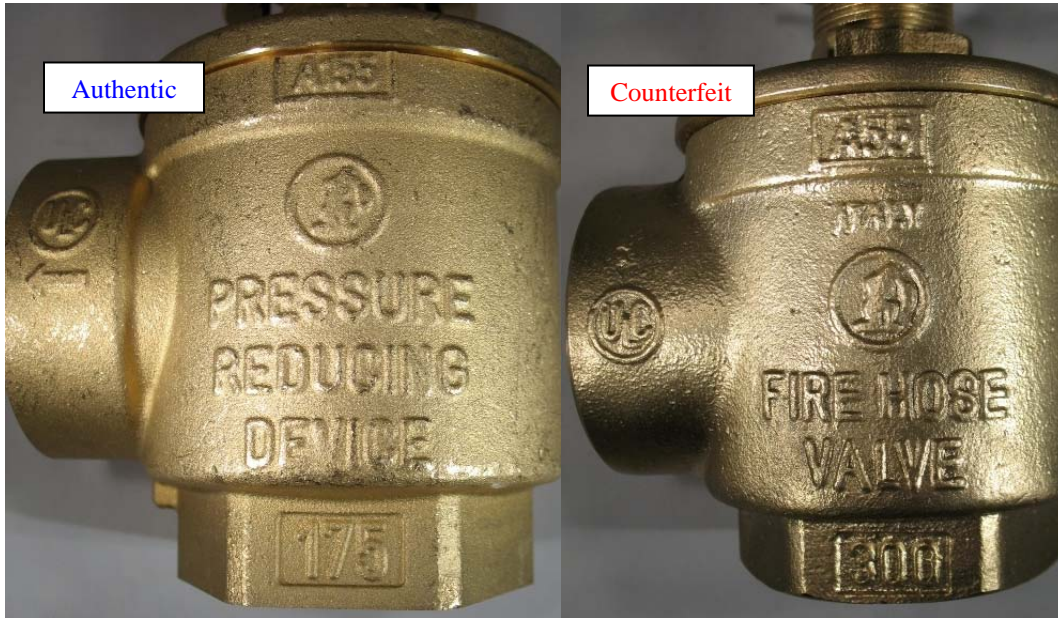
Figure 5 above shows the body of the authentic 1-1/2" A155 in plain brass on the left and the counterfeit 1-1/2" A155 on the right. The counterfeit is marked as a model "A55" which is incorrect, as an authentic model A55 is not equipped with the pressure reducing hardware on the valve stem but the counterfeit version is equipped with such hardware. Additionally, the authentic valve body has casting marks that include the words "PRESSURE REDUCING DEVICE," the pressure rating "175" and an arrow on the outlet indicating the direction of flow. The counterfeit valve body is instead marked with "ITALY" above the Giacomini logo, the words "FIRE HOSE VALVE" and the pressure rating "300" below it and it also lacks the flow direction indication on the outlet. There are other visual differences in the color and finish of the brass and some of the casting details around the outlet, inlet, as well as the overall dimensions of the valve body.

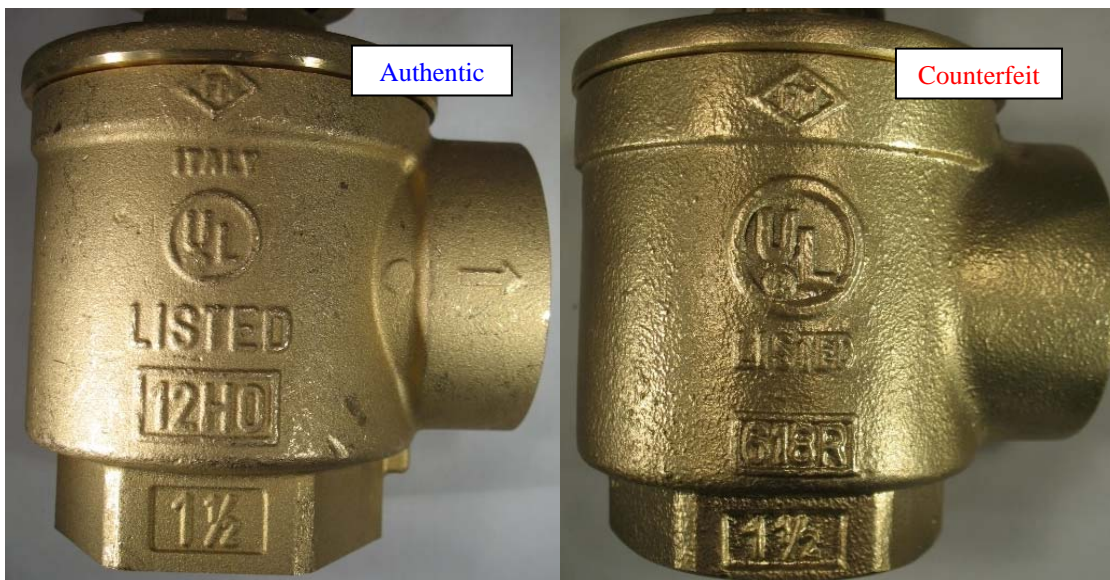
Figure 6 (previous page) shows the reverse side of the valve bodies of those shown in Figure 5. The counterfeit valve lacks the “ITALY” marking on this side that the authentic valve has. The UL® control number is incorrect on the counterfeit valve and it also lacks the flow direction arrow that is included on the authentic casting. The physical differences in the casting beyond the markings are consistent with those seen in Figure 5 as well.

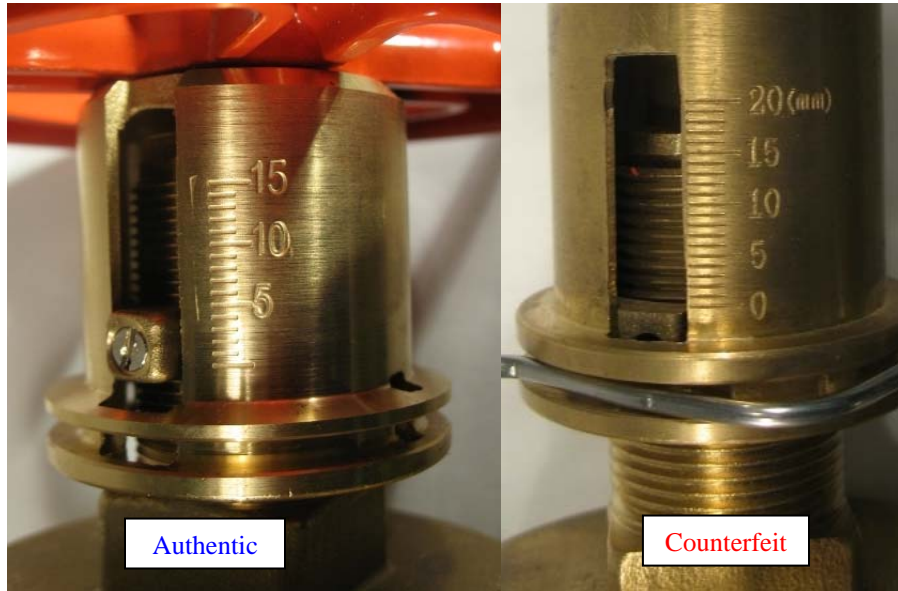
Figure 7 above shows the differences in the markings on the valve stem caps on the 1-1/2” model. The authentic version on the left is marked from 0 to 15 without any indication of ‘unit’. The counterfeit valve has a stamping indicating units of “mm” and the scale is from 0 to 20.

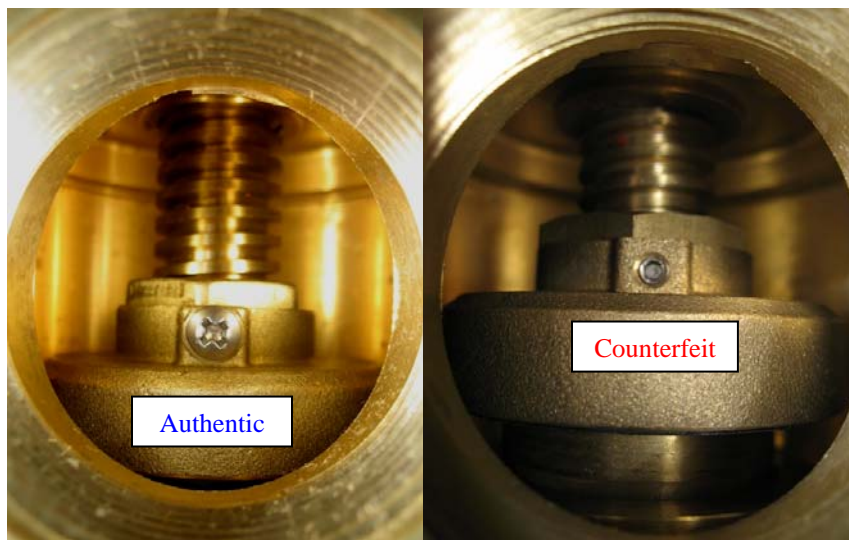
Figure 8 above shows the seat washer set screws on the authentic 1-1/2” valve and on the counterfeit 1-1/2” valve. The authentic set screw is a pan head Phillips type, while a headless Allen socket type screw is used in the counterfeit.

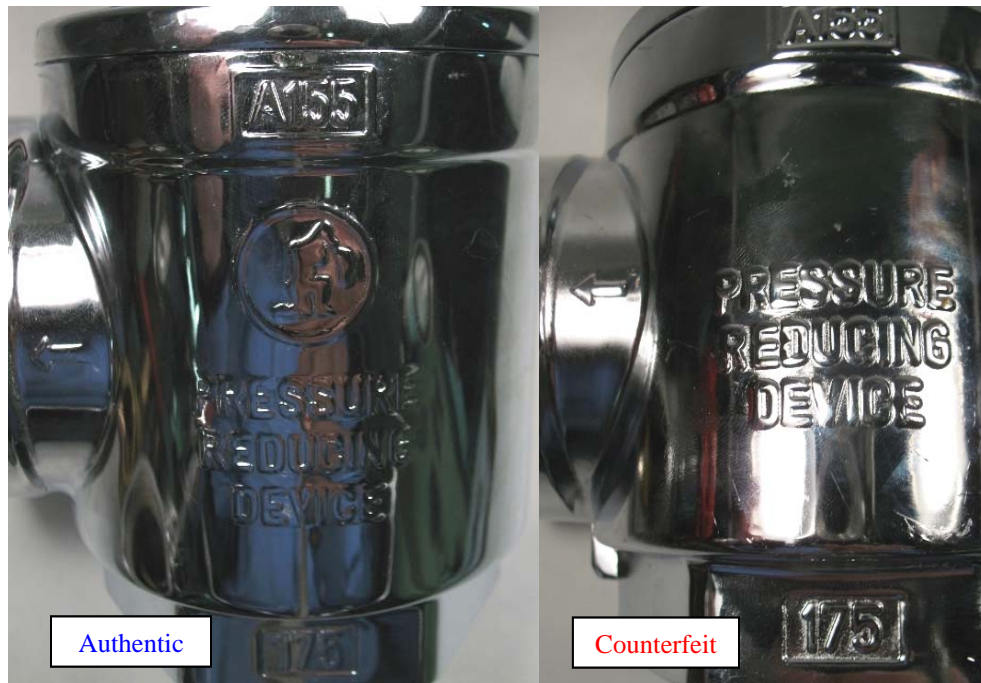
Figure 9 above shows the markings on the valve bodies of the authentic and counterfeit 2 1/2" A155 valves. The only difference between the two is that the Giacomini logo is missing from the counterfeit valve.

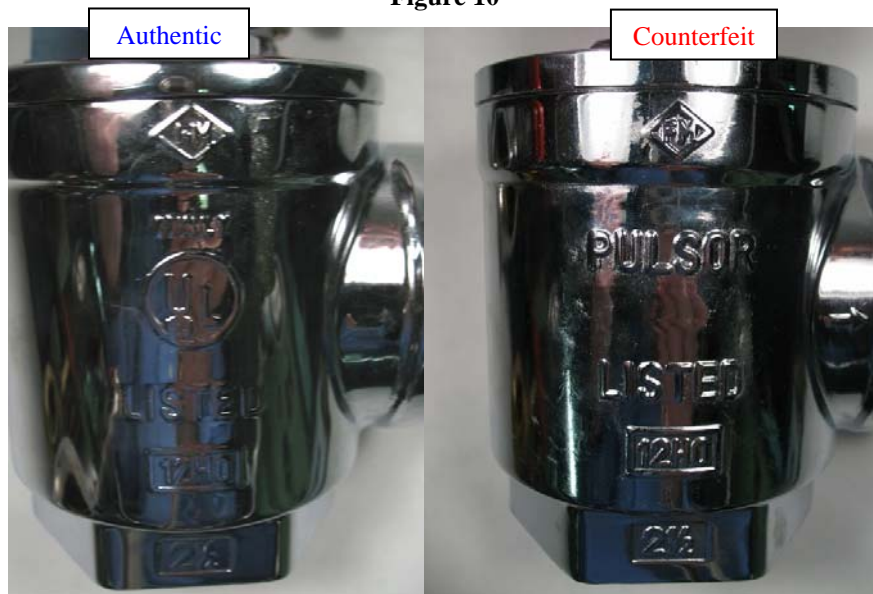
Figure 10 above shows the markings on the opposite side of the valve body as those in Figure 9. The counterfeit valve on the right has the word "PULSOR" where the UL® mark and the word "ITALY" is found on the authentic version. The markings are otherwise similar.

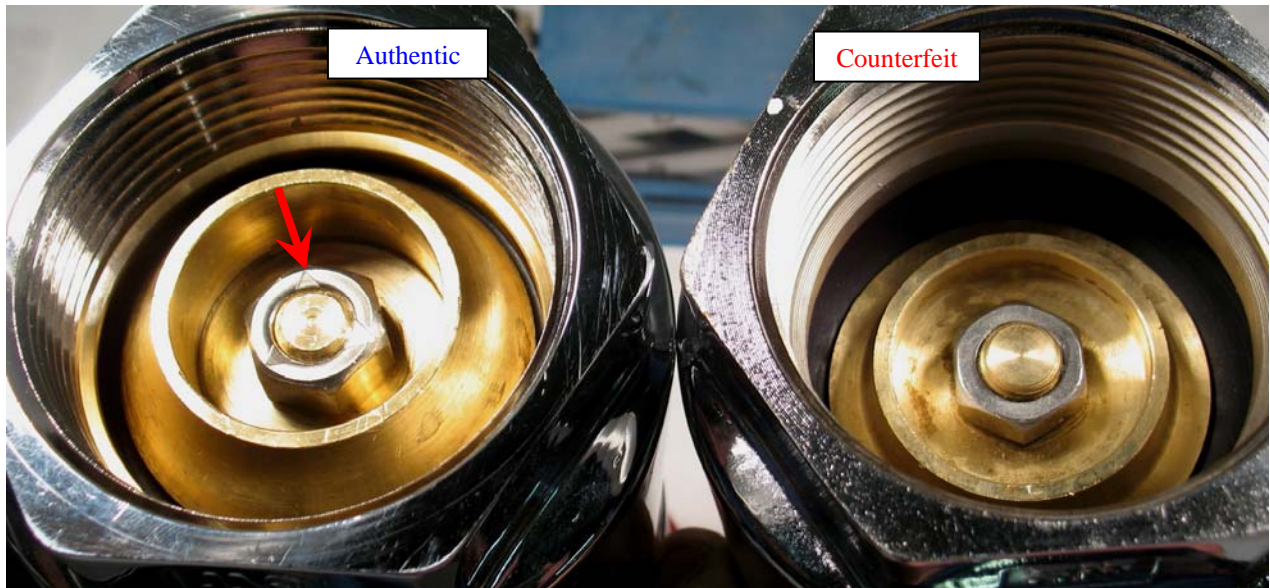
Figure 11 above shows the difference in the valve seats of the authentic and counterfeit 2-1/2" valves. The authentic valve seat extends further than the counterfeit seat. Also of note are the three marks on the nut of the authentic valve which are not present on the counterfeit version. These detent marks, indicated by the red arrow, help affix the nut to the valve stem to prevent the nut from backing off in service. It is unknown whether the nut on the counterfeit valve has any means of securing it from turning and subsequently falling from the stem while in service. The nut on the authentic 1 1/2" valve is shown below left, and also has detent marks on it. The nut on the counterfeit 1 1/2" valve does not.
