## **Product Alert**

Type of Notification: Suspect Counterfeit

FM Approvals has been made aware of suspect counterfeit automatic fire sprinklers found in Vietnam bearing an FM Approvals mark. FM Approvals has neither tested nor certified this product.

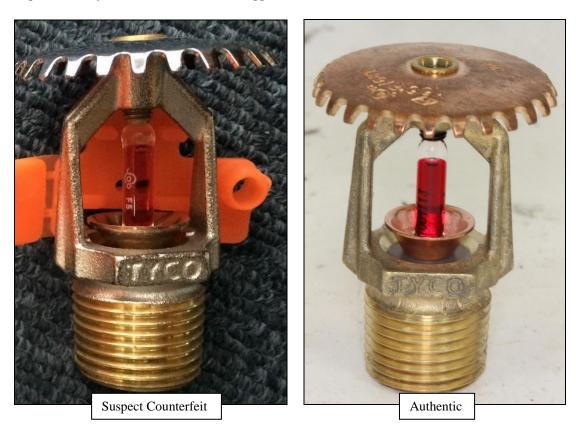
Figure 1 below shows a comparison between the suspect counterfeit upright style sprinkler (left) with an authentic Tyco TY3151 sprinkler (right). The sprinkler on the left uses a Job model F5 glass bulb while authentic Tyco TY3151 sprinklers use only the Job model G5 glass bulb or Geissler 5mm bulb (shown in Figure 2 below). Authentic TY3151 sprinklers do not use chrome plated deflectors with brass frames as the suspect counterfeit sprinkler on the left does; the sprinkler should either appear with no coating (as pictured on the right) or with both the frame and deflector plated or coated. The orifice cap used in the sprinkler of the left (which also supports the pip end of the glass bulb, referred to as the "button" by Tyco) appears to be machined from brass, while authentic Tyco TY3151 sprinklers only use buttons formed from copper.

**Figure 1.** Comparison of a sprinkler found bearing the suspect counterfeit FM Approvals mark and what appears to be an upright style deflector (left) and an authentic Tyco TY3151 (right). *Photograph at left courtesy of Underwriters Laboratories, reproduced with permission.*

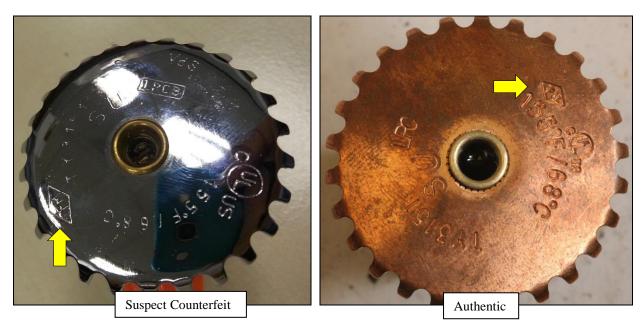
Figure 3 below shows a comparison of the deflector markings on the suspect counterfeit upright style sprinkler (left) and an authentic TY3151 (right). The markings appear to be largely the same on both deflectors. There are only subtle differences in placement, size, and font.

**Figure 3.** The suspect counterfeit FM Approvals mark (left) and an authentic FM Approvals mark on a Tyco TY3151 (right). *Photograph at left courtesy of Underwriters Laboratories, reproduced with permission.*

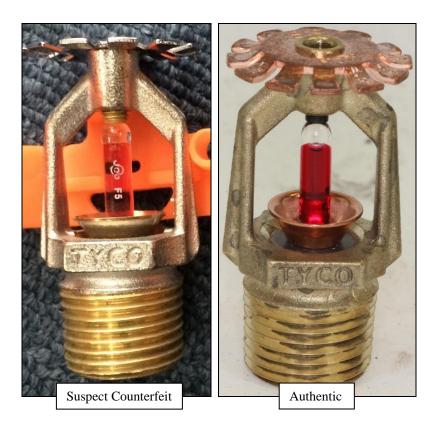
Figure 4 on the following page shows the suspect counterfeit pendent style sprinkler found bearing a suspect counterfeit FM Approvals mark (left) and an authentic Tyco TY3251 pendent sprinkler (right). The "F5" is clearly visible on the bulb in the sprinkler on the left. The authentic sprinkler on the right has a Geissler bulb. Like the suspect counterfeit upright style sprinkler, the pendent also has a chrome plated deflector attached to a brass frame. Authentic Tyco sprinklers only use a chrome plated deflector with a chrome plated frame or an uncoated deflector and uncoated frame.

**Figure 4.** Comparison of a sprinkler found bearing the suspect counterfeit FM Approvals mark and what appears to be a pendent style deflector (left) and an authentic Tyco TY3151 (right). *Photograph at left courtesy of Underwriters Laboratories, reproduced with permission.*

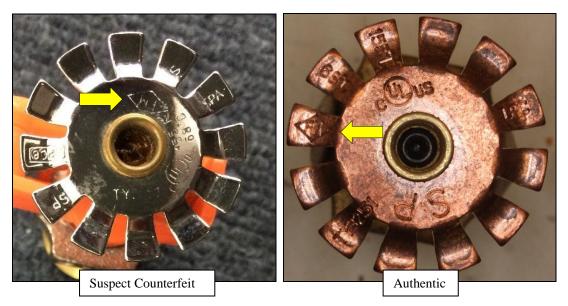
Figure 5 on the following page shows the pendent style deflector bearing the suspect counterfeit FM Approvals mark (left) and an authentic Tyco TY3251 (right). The markings are again largely the same, although more markings appear on the tines of the deflector on the authentic sprinkler.

**Figure 5.** Suspect counterfeit FM Approvals mark on the pendent style sprinkler (left) and the authentic FM Approvals mark on a Tyco TY3251 (right). *Photograph at left courtesy of Underwriters Laboratories, reproduced with permission.*
