Product Alert

June 25, 2014

Type of Notification: Counterfeit

FM Approvals has been made aware of automatic fire sprinklers found in Vietnam bearing a counterfeit FM Approvals mark. FM Approvals has neither tested nor certified this product.

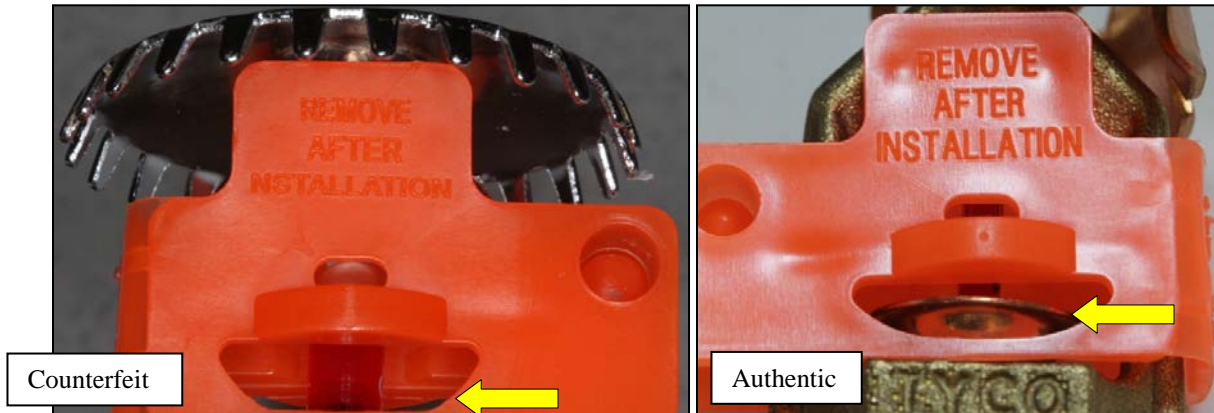
Figures 1 through 3 below show a comparison of the shipping guard supplied with the counterfeit sprinklers and an authentic Tyco shipping guard. The two guards look very similar, including a cutout portion highlighted by the yellow arrows. The cutout in the authentic guard is to allow room for the lip of the copper button. The design of the button on the counterfeit sprinkler has no such protrusion, however, the cutout was copied nonetheless.

Figure 1 – Comparison of a counterfeit shipping guard (left) and an authentic Tyco shipping guard (right)

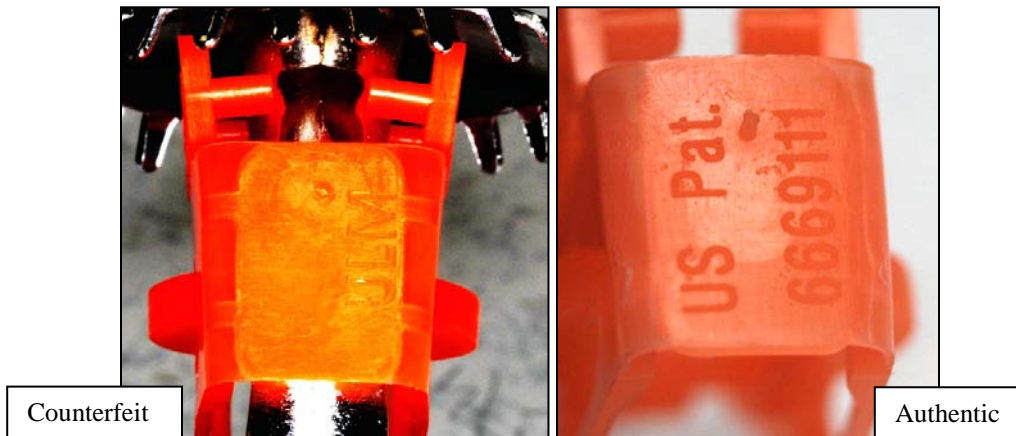
Figure 2 shows a side view of the shipping guards. The applicable US patent number is shown on the authentic Tyco guard whereas the counterfeit guard has the letters “ULM” molded into it.

Figure 2 – Comparison of a counterfeit shipping guard (left) and an authentic Tyco shipping guard (right)

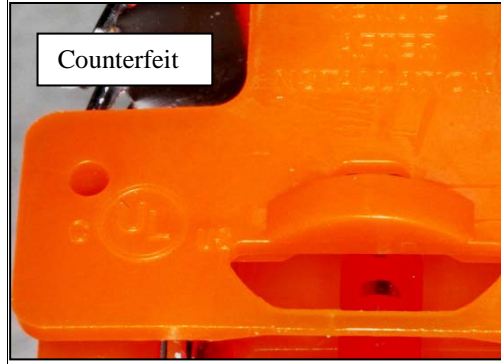
Figure 3 below shows the opposite side of the counterfeit guard as shown in Figure 1. The UL Listed marking appears on the counterfeit protector while UL Listed mark does not appear on the authentic guard.

Figure 3 – Counterfeit shipping guard showing the UL Listed marking

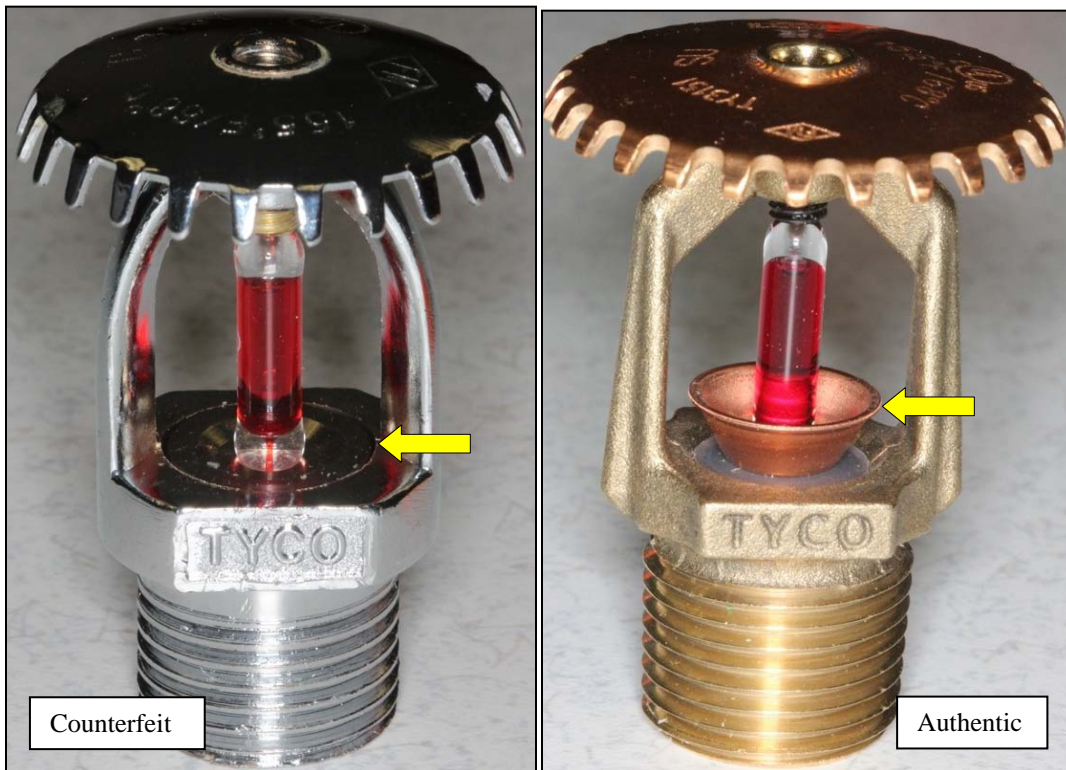
Figure 4 below shows the counterfeit upright sprinkler (left) and an authentic Tyco TY3151 sprinkler (right). The shape of the frame arms are different on the counterfeit, and the casting mark in the wrench boss uses raised lettering instead of the recessed lettering used in the authentic sprinkler. The yellow arrows identify the buttons on the respective sprinklers. The button used in the counterfeit sprinkler is machined out of a solid blank while the authentic sprinkler uses a button stamped from a copper sheet.

Figure 4 – Profile view of counterfeit upright sprinkler (left) and an authentic Tyco TY3151 sprinkler (right)

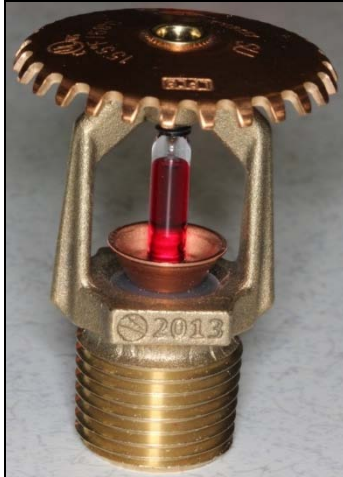
Figure 5 below shows the opposite profile view of an authentic TY3151 sprinkler. The counterfeit is not shown as it is the same as the profile view shown above left. The authentic sprinkler, however, has the manufacture year cast into the wrench boss on this side, as well a casting pattern identification mark.

Figure 5 – Opposite profile of an authentic TY3151

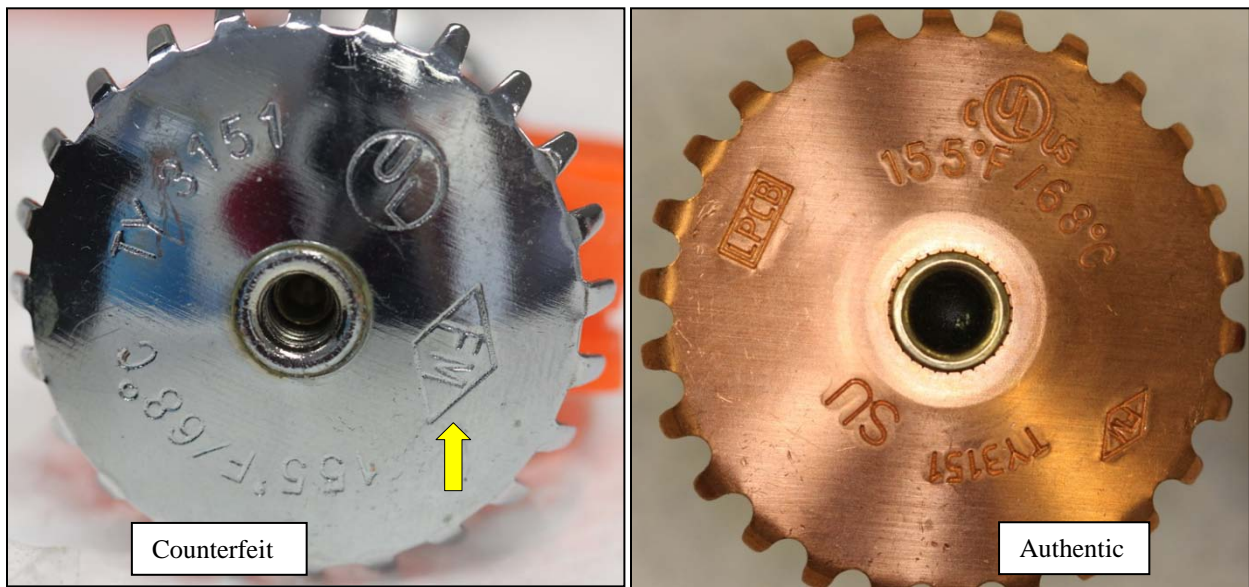
Figure 6 below shows the deflectors of the counterfeit (left) and authentic TY3151 (right) sprinklers side by side. The counterfeit sprinkler lacks the orientation designation “SU” as well as the Loss Prevention Certification Board marking “LPCB.” The yellow arrow indicates the counterfeit FM Approvals mark.

Figure 6 – Markings on the deflectors of the counterfeit sprinkler (left) and an authentic TY3151 (right)

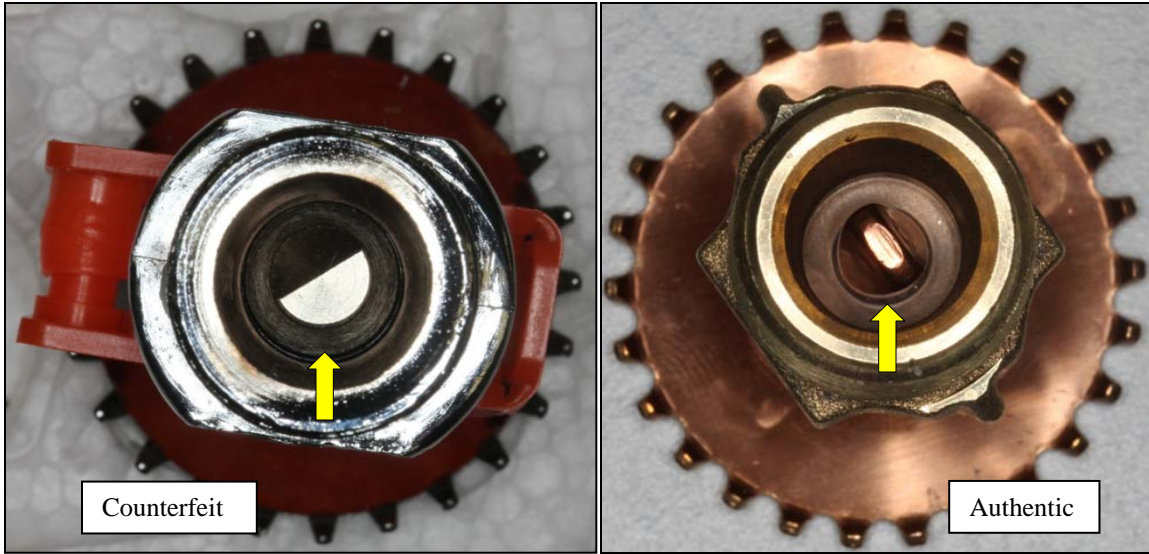
Figure 7 below shows a comparison between the underside of the buttons used in the counterfeit sprinkler (left) and an authentic TY3151 (right). As noted above Figure 4, the counterfeit button is machined, and the underside has an angled slope across half the diameter. The authentic button has no such feature, and tapers to a smaller, rectangular flat bottom with mostly rounded edges owing to the stamped forming.

Figure 7 – Inlet and button underside of the counterfeit sprinkler (left) and an authentic TY3151 (right)

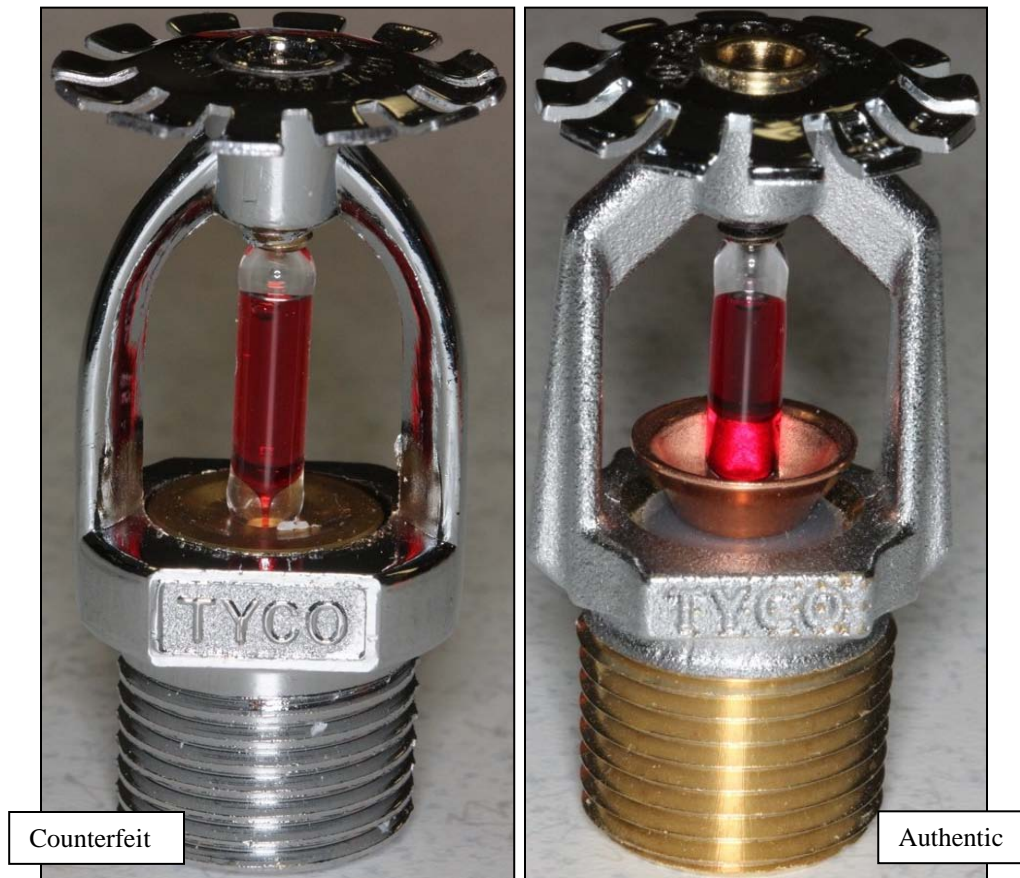
Figure 8 below shows the pendent sprinkler identified as counterfeit on the left and an authentic Tyco TY3251 pendent sprinkler on the right. The frame, button and bulb of the counterfeit pendent sprinkler look identical to the same parts used in the counterfeit upright sprinkler. Similarly, the cast wrench boss marking on the counterfeit pendent uses raised lettering while the authentic sprinkler has recessed lettering. The chrome plating on the counterfeit sprinkler frame exhibits a smooth, reflective quality while the chrome on the frame on the authentic TY3251 is a matte like finish. It is also noteworthy that the inlet threads on the counterfeit sprinkler have chrome plating applied to them, indicating the plating was done after machining. On authentic Tyco sprinklers, the frame is plated prior to machining resulting in bare brass on machined surfaces, including the inlet threads, the inlet bore and the spring seal seat.

Figure 8 - Profile view of counterfeit pendent sprinkler (left) and an authentic Tyco TY3251 sprinkler (right)

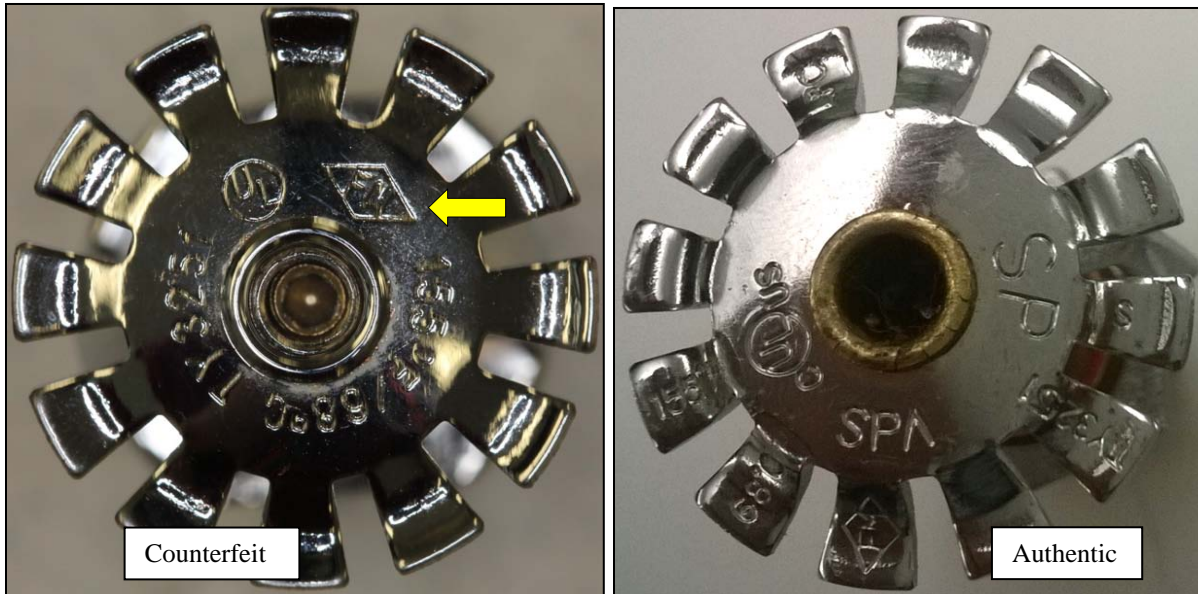
Figure 9 below shows close views of the markings on the deflector of the counterfeit sprinkler (left) and an authentic TY3251 sprinkler (right). Many of the markings on the authentic sprinkler are stamped into the tines whereas all the markings on the counterfeit sprinkler appear in a circular pattern around the load screw. Missing from the counterfeit deflector is the VdS marking, the LPCB marking, and the orientation marking "SP." The yellow arrow indicates the counterfeit FM Approvals mark.

Figure 9 - Markings on the deflectors of the counterfeit pendent sprinkler (left) and an authentic TY3251 (right)

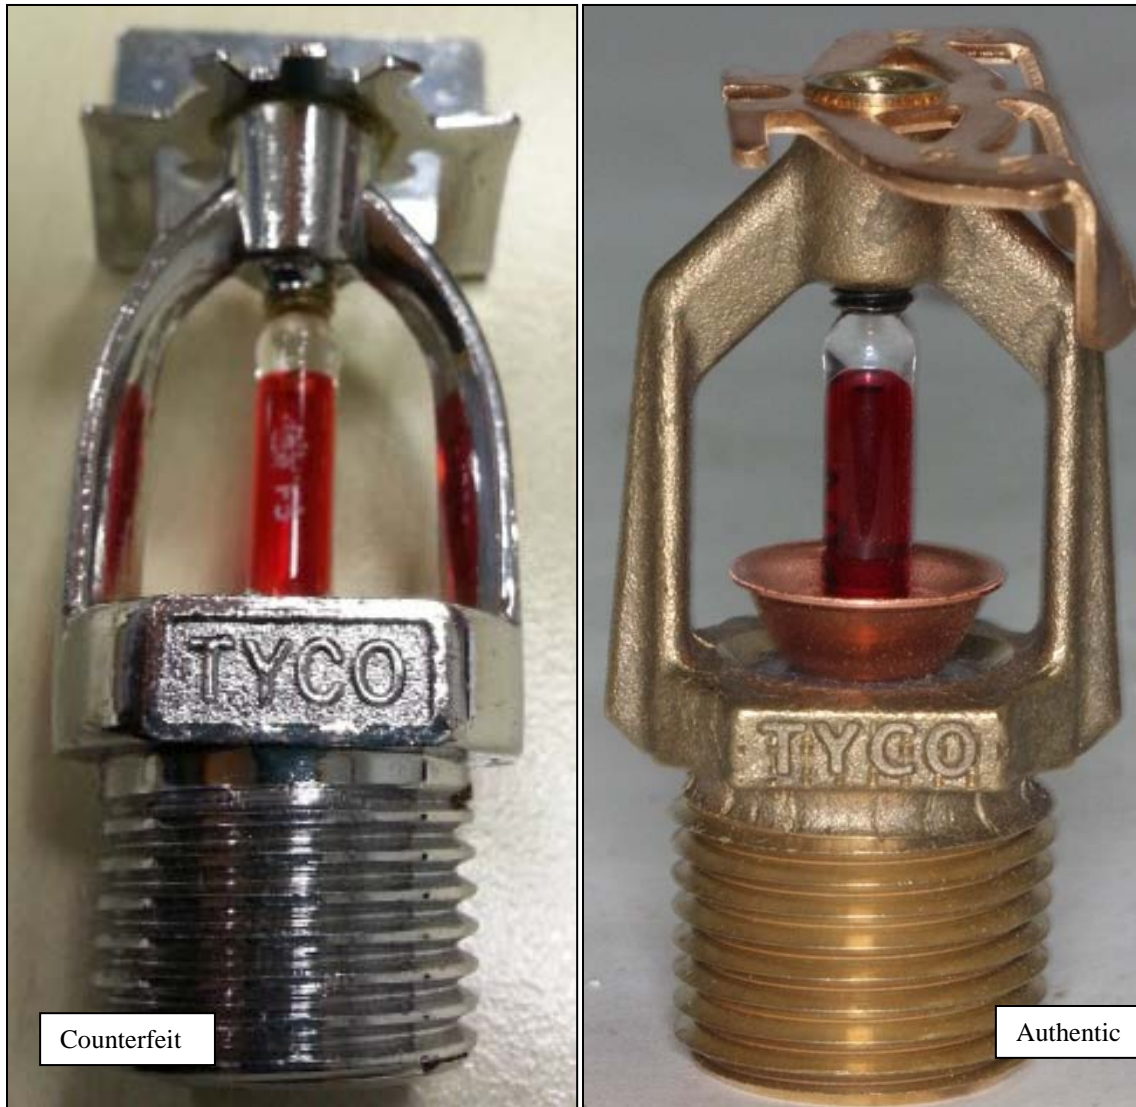
Figure 10 below shows the horizontal sidewall sprinkler identified as counterfeit on the left and an authentic Tyco TY3351 horizontal sidewall sprinkler on the right. The frame, button and bulb of the counterfeit sprinkler look identical to the same parts used in the counterfeit upright and pendent sprinklers. Similarly, the cast wrench boss marking on the counterfeit uses raised lettering while the authentic sprinkler has recessed lettering. The chrome plating on the counterfeit sprinkler frame has the same finish quality as the upright and pendent. The deflector on the counterfeit sprinkler in this case is very different from the authentic version. The orientation is also different, as the authentic TY3351 is intended to be installed with its frame arms perpendicular to the ceiling, while the counterfeit sprinkler uses a deflector style that would indicate installation with frame arms parallel to the ceiling.

Figure 10 - Profile view of counterfeit horizontal sidewall sprinkler (left, photo courtesy of UL LLC) and an authentic Tyco TY3351 sprinkler (right)

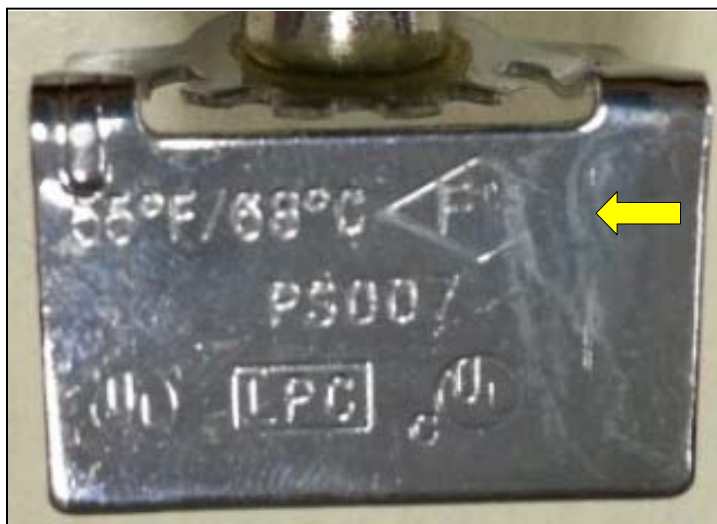
Figure 11 below shows the deflector of the counterfeit horizontal sidewall sprinkler. The yellow arrow indicates the counterfeit FM Approvals marking. The markings on the authentic TY3351 are shown below in Figure 12 for comparison. Several markings appear on the authentic deflector that do not on the counterfeit. Additionally, the counterfeit has a different sprinkler identification marking (SIN) “PS007,” which is a designation assigned to Protector Safety Ind. Co. rather than Tyco Fire Products. Protector Safety Ind. Co. did not manufacture the counterfeit sprinklers.

Figure 11 – Markings on the counterfeit horizontal sidewall (photo courtesy of UL, LLC)

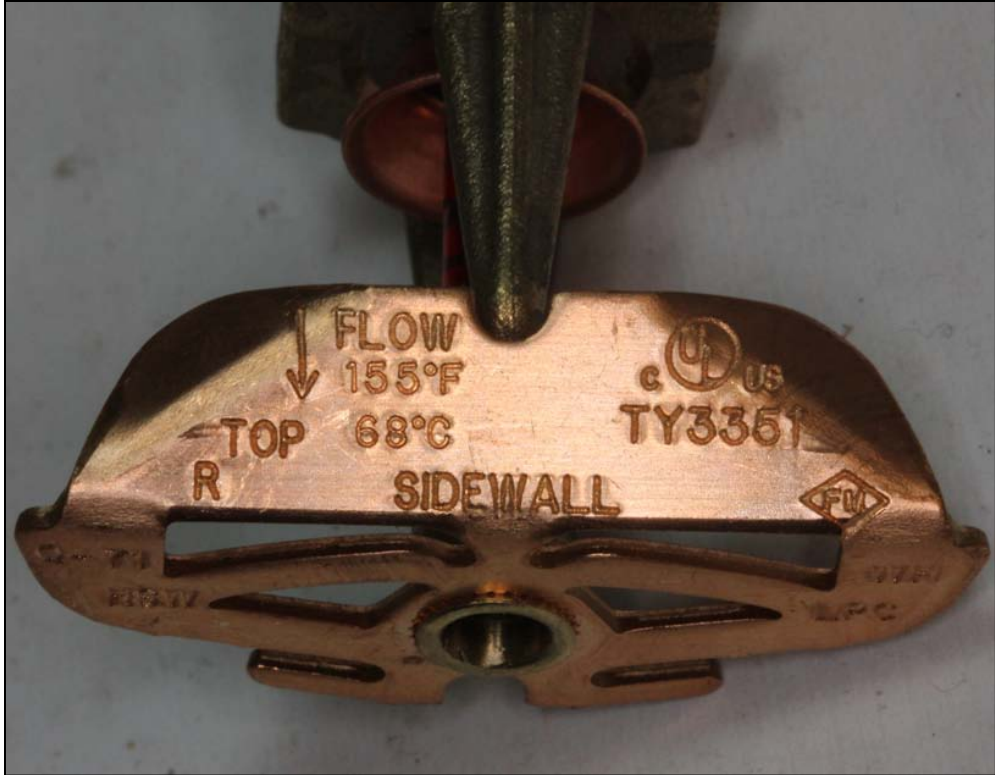
Figure 12 – Markings on an authentic Tyco TY3351 sprinkler

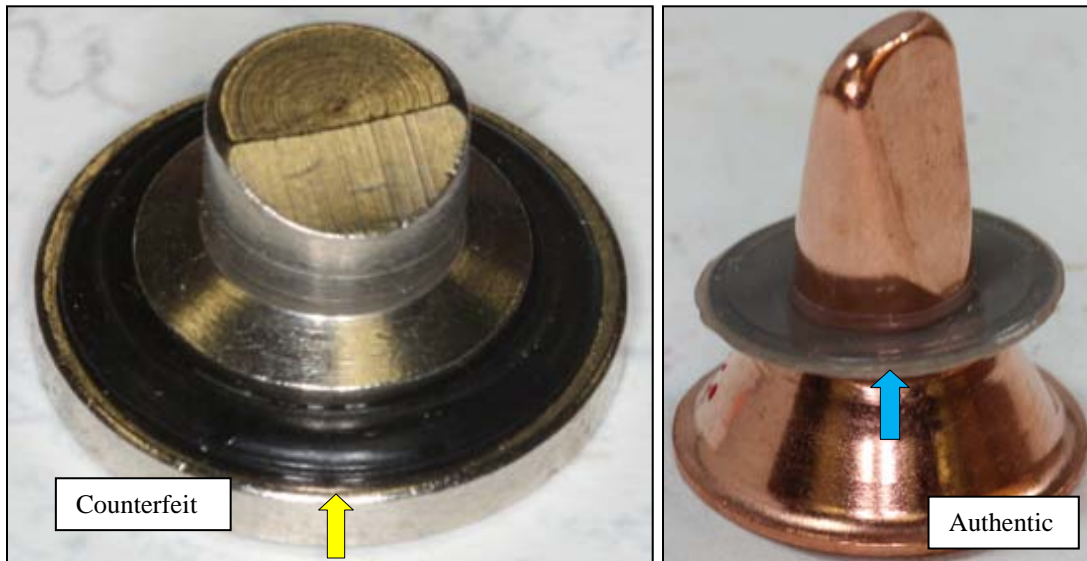
Figure 10 below shows the button from one of the counterfeit sprinklers (left) and the button from an authentic Tyco bulb sprinkler (right). The yellow arrow indicates the o-ring type seal employed by the counterfeit sprinklers to seal the orifice. This type of design has been shown in the past to be unreliable. The blue arrow indicates the PTFE coated spring washer type orifice seal used in the authentic Tyco sprinklers. Designs using a spring washer seal tend to operate more reliably and loading on the operating element tends to be better controlled.

Figure 13 – Button and o-ring seal used in the counterfeit sprinklers (left) and button and spring washer seal used in authentic Tyco bulb sprinklers (right)
